Initial Seismic Assessment Report

Address: State Highway 48, Mt Ruapehu 3951, Old Fire Station/Garage at Chateau Tongariro

Date: **29 September 2023**

Project Number: **220138**

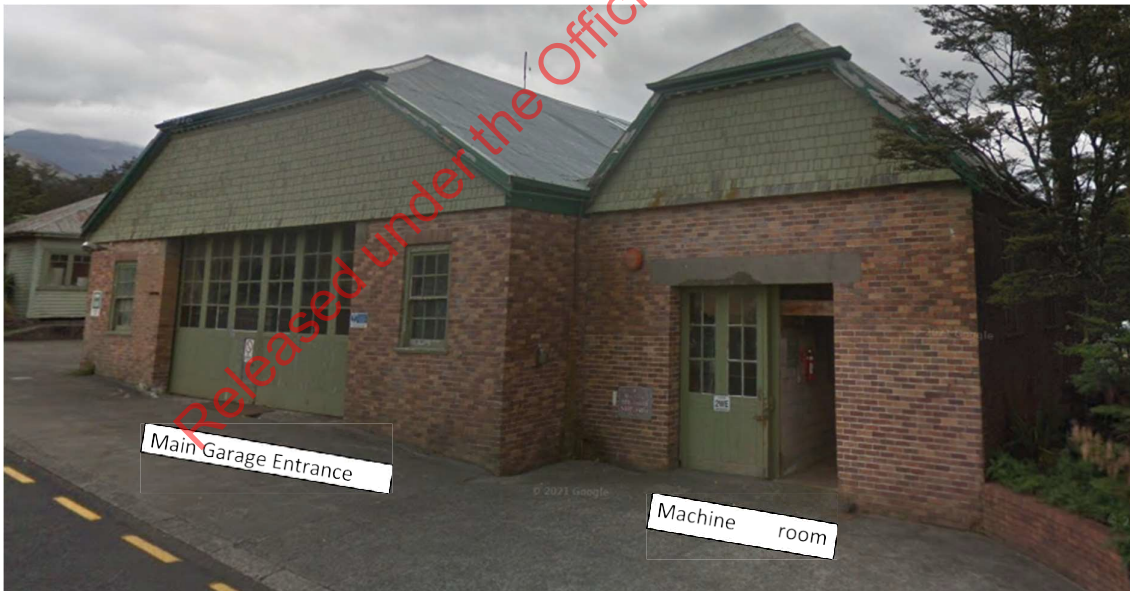
Figure 3 – Exterior view of the building Front (East) elevation

- The hollow brick masonry veneer cladding is limited to 20%NBS due to out-of-plane capacity.
- The unreinforced masonry façade walls on the east elevation are limited to 45% NBS(IL2) limited by out-of-plane bending capacity.

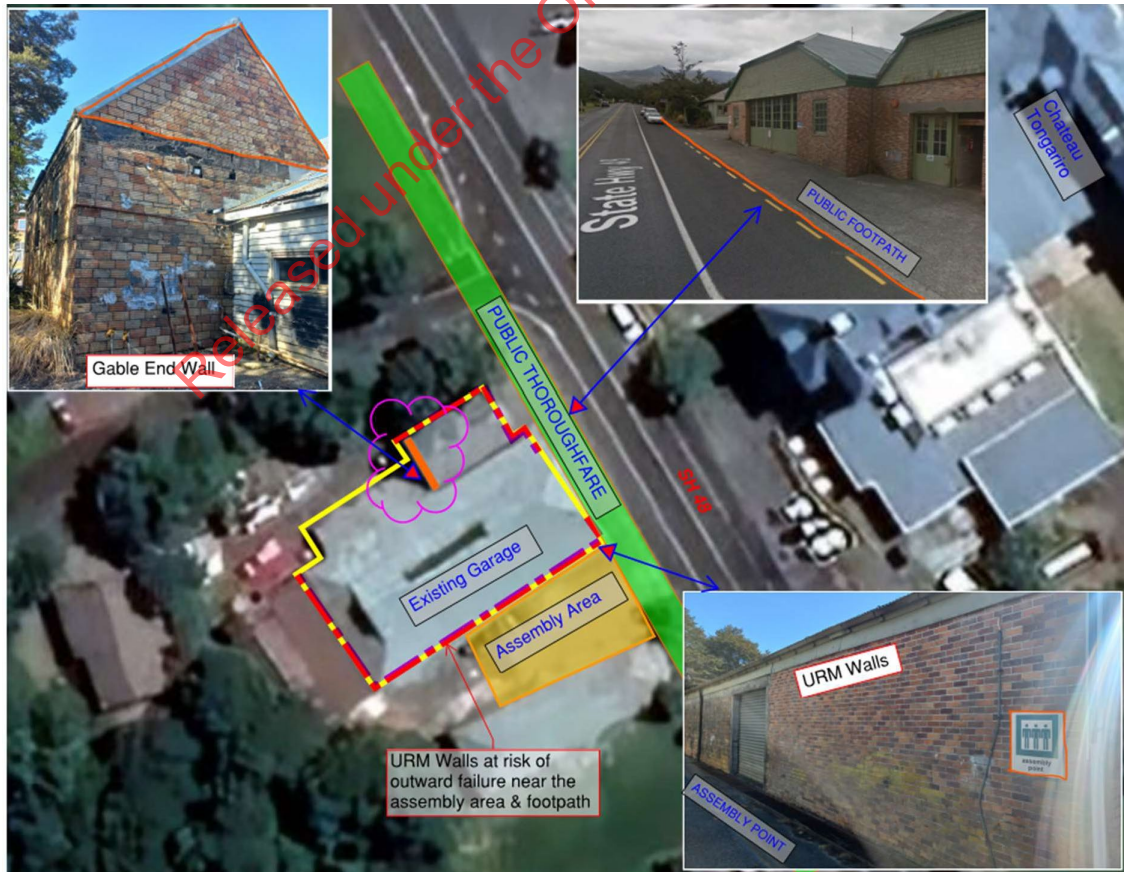
Figure 4 – Aerial view of building and surroundings with identification of structural elements and risk exposure

- The main risk lies to the public around the building, particularly near the designated 'Assembly Point' on the South-East wall of the building (figure 4). We suggest removing the designated emergency point from adjacent to the building and relocating it away from the building somewhere safe.

- At the rear of the building on western elevation (figure 4 clouded area) where the Gable-end wall poses a potential risk of collapse, Miyamoto suggest placing localized cordons to deter public from accessing the area.

- The front façade walls of the building with solid brick masonry could potentially pose risk to public throughfare. Our preliminary assessment indicates that these walls are not rated less than 34%NB. A DSA with further investigations might change this outcome. Additionally, the frequency of foot traffic on this foot path is unknown to us, therefore Miyamoto have excluded this in our review until further investigations is done.

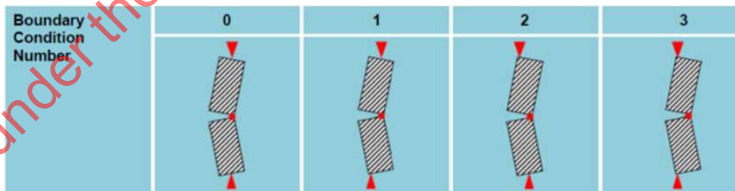
Title:	Tongariro Chateau - URM Garage Building	Job No.	220138
Description:	East (Front) wall north corner - 3 bricks thick	Page No.	
		Date	28/09/23
		Author:	SL
		Reviewer:	
		Revision:

Note the fixings were observed to be corroded and unlikely to contribute in tying wythes

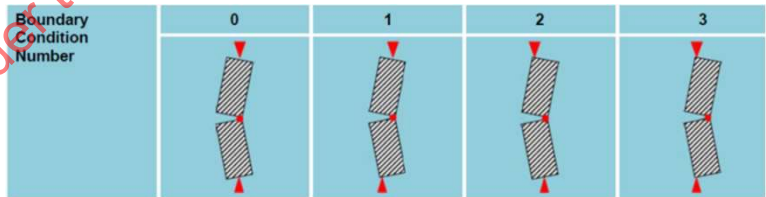
Title:	Tongariro Chateau - URM Garage Building	Job No.	220138
		Page No.	
Description:	Gabled roof end wall (west elevation)	Date	25/09/23
		Author:	SL
		Reviewer:	
		Revision:

- The gable end wall on the west elevation is limited to 15%NBS due to lack of out-of-plane bending capacity. The wall cantilevers approximately 3m above the bond

beam level and is susceptible to outwards fall if sustained damage in a moderate level of shaking.
