CRITICAL OPEX SPEND - Authorisation Request

Kapowairua to Tapotupotu Track (part of Te Paki Coastal Track)

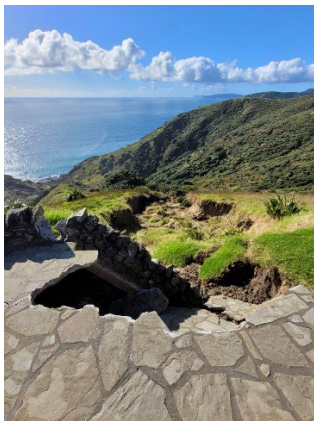
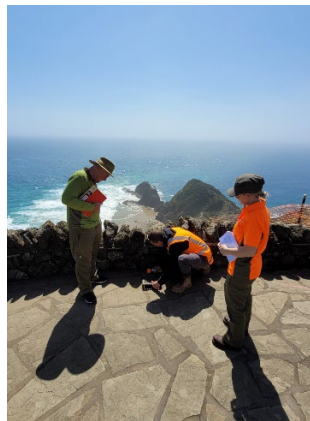
Te Rerenga Wairua works site

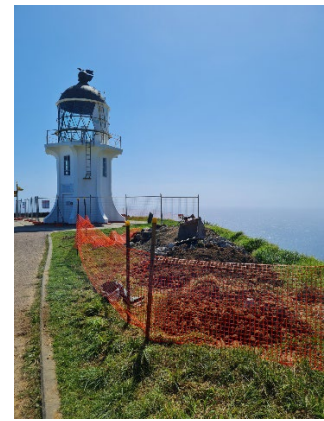
Engineering assessments were completed within a week, which enabled the track to partially reopen while plans were made to undertake repairs. The inspections identified three areas of substantial work that needed immediate attention: Cape Reinga/Te Rerenga Wairua, Tapotupotu, and Te Paki Stream Roads. Cases were immediately put to the Cyclone Recovery Taskforce to access the budget to get work underway.

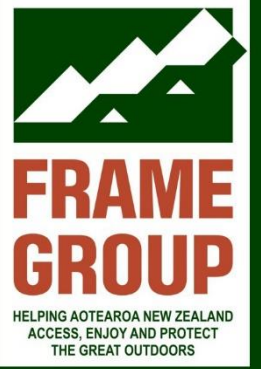
Cyclone Damage Inspections Pandora Track, Cape Reinga and Waitahora Lagoon

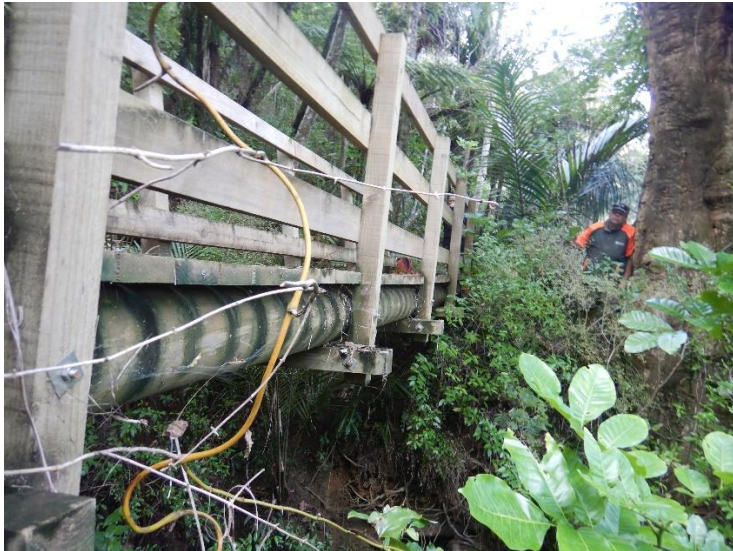
Figure 1: All pole bridges in good condition

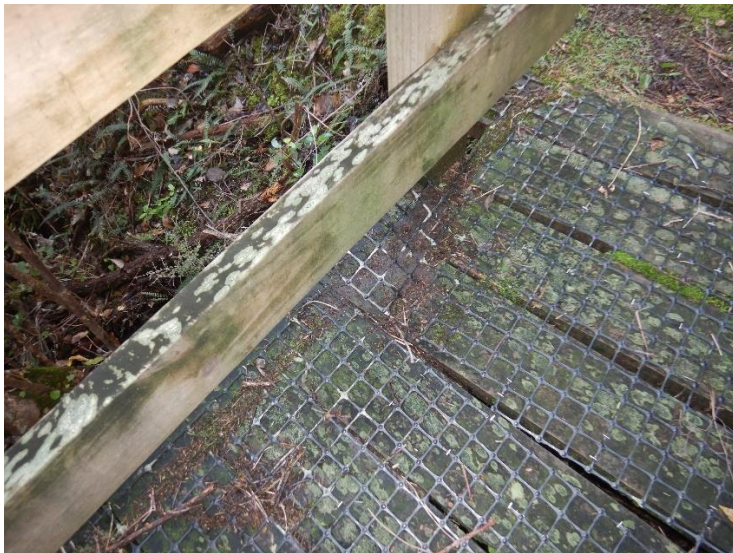
Figure 2: Deck mesh lifting on bridge 023974

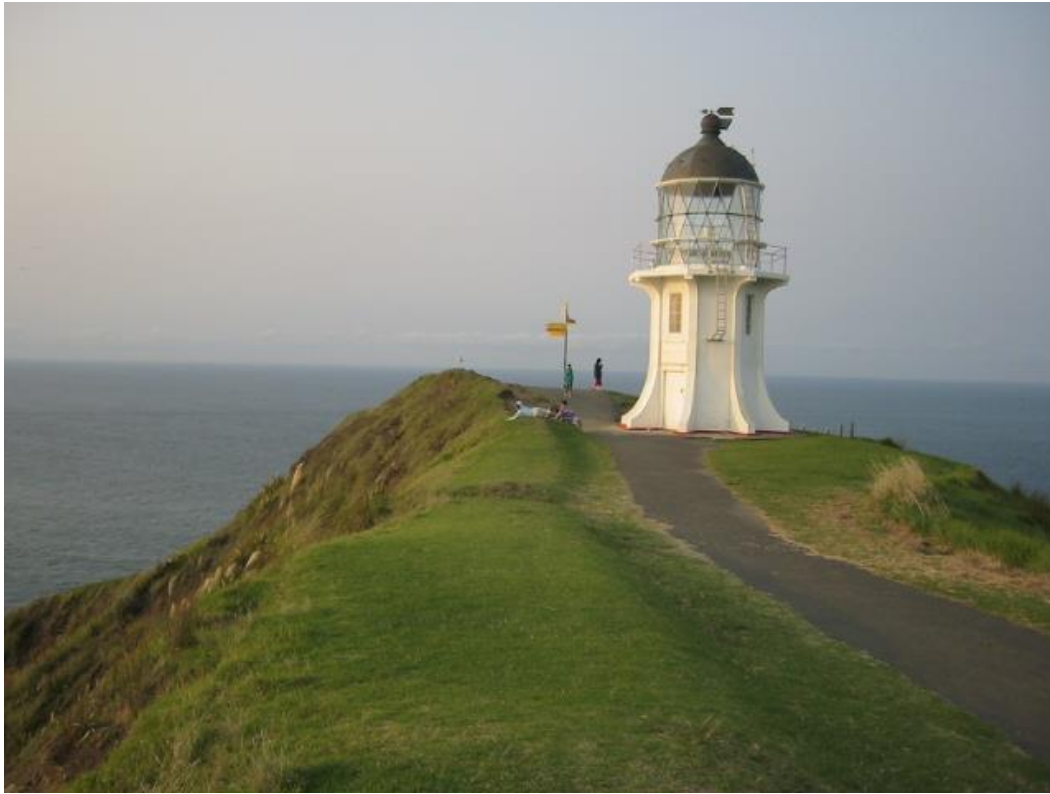
Figure 7: Cape Reinga Lighthouse area in 2003 showing the original rock mound to the west of the lighthouse and the low ground to the east.

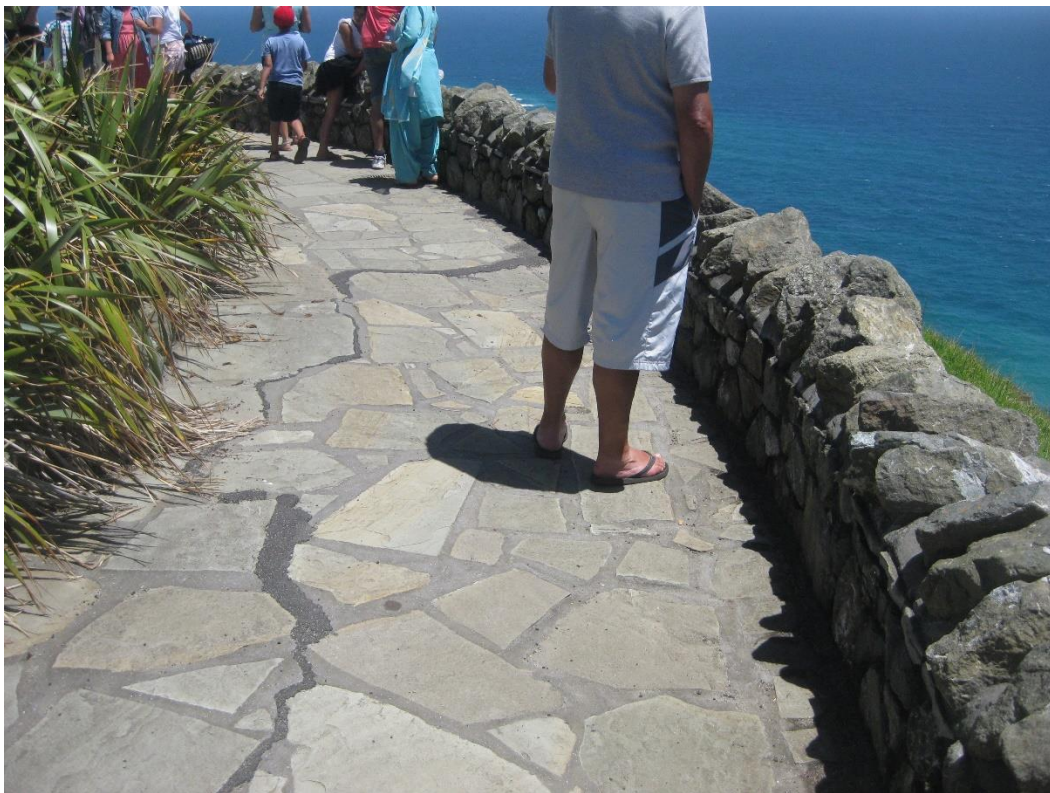
Figure 10: Evidence of cracking and settlement of the paving over the filled area after repairs had been undertaken in late 2013.

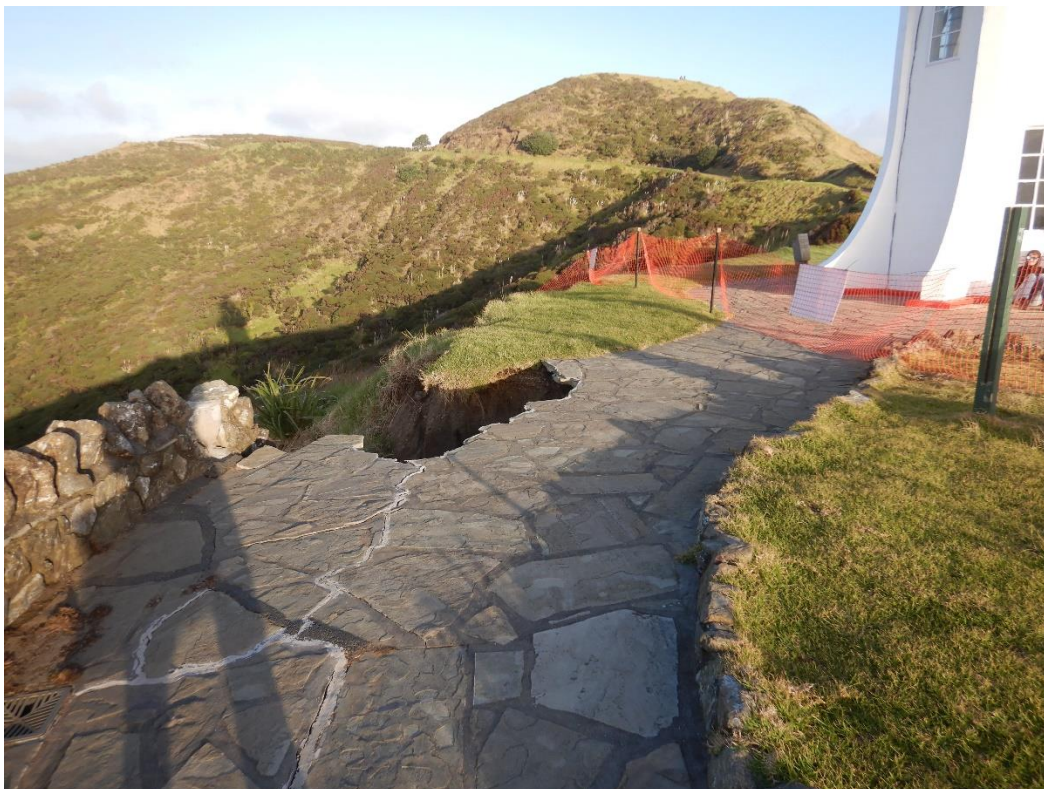
Figure 11: Failed section of paving and wall on the eastern side of the lighthouse area.

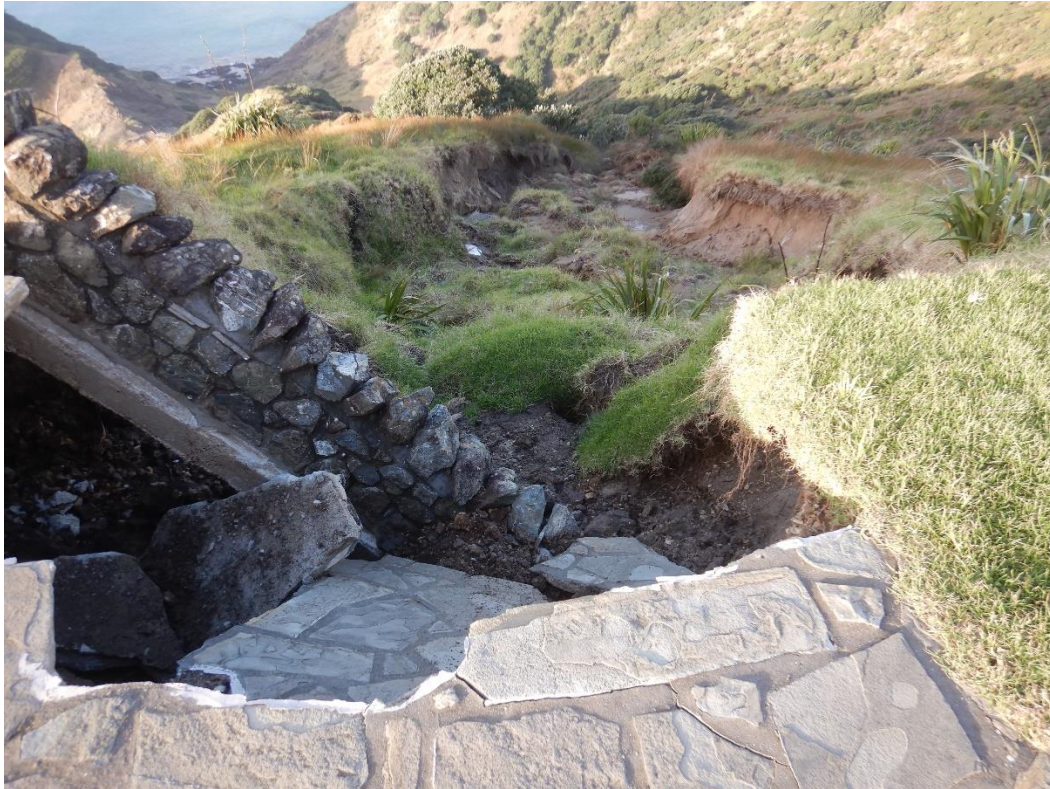
Figure 12: A significant amount of soil material has flowed down the steep slip path from under the collapsed wall and paving area.

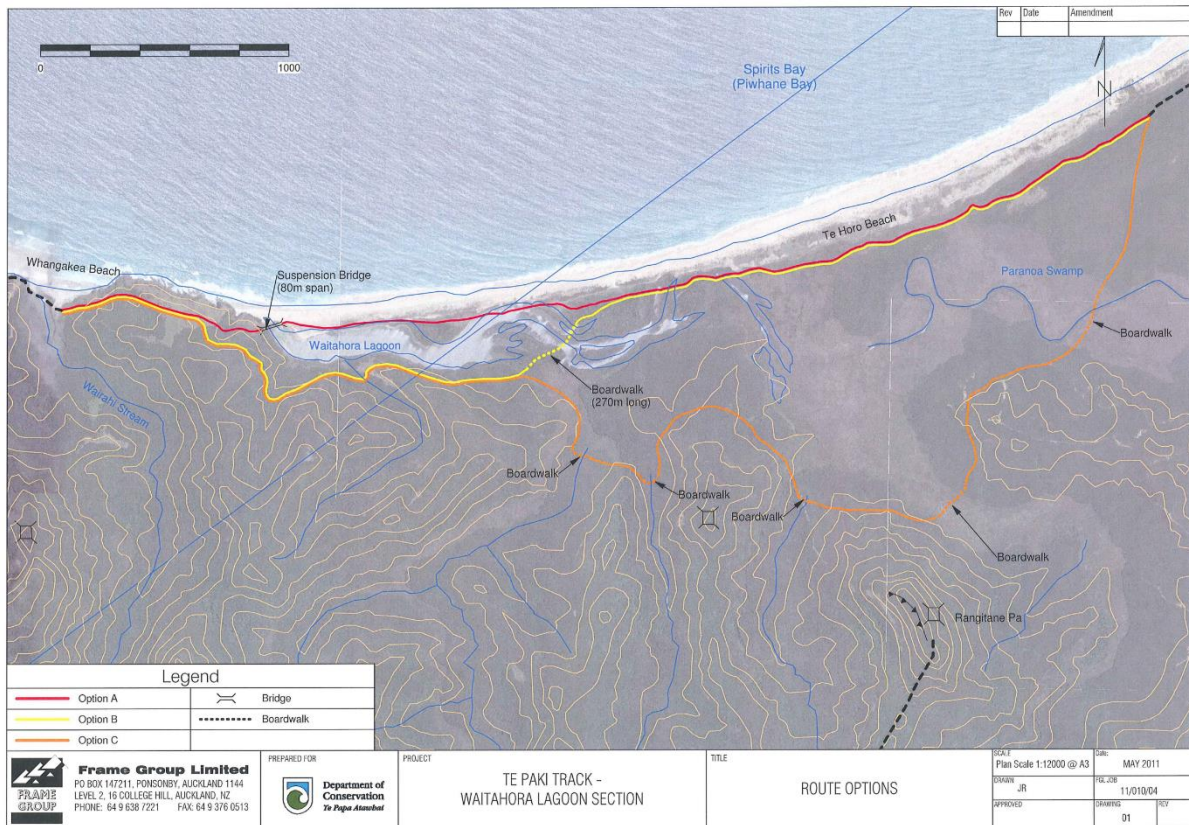
Figure 13: Route Options from the 2011 Frame Group Feasibility Report

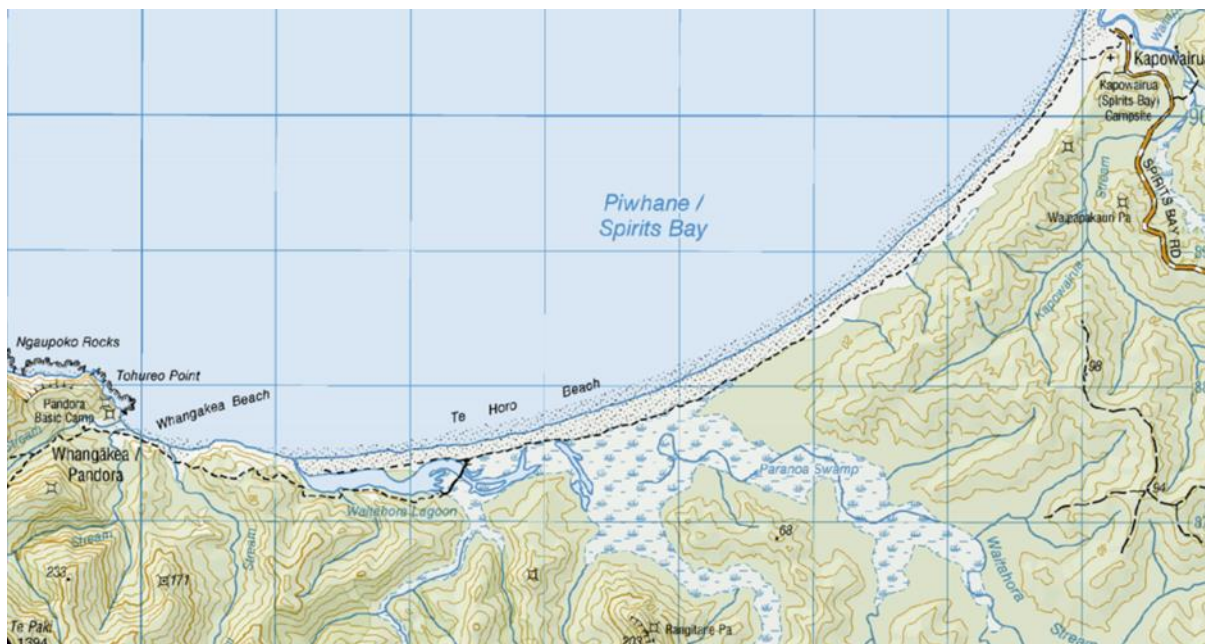
Figure 14: Te Paki Trail between Kapowairua and Whangakea/Spirits Bay showing the current boardwalk location across the Waitahora Lagoon boardwalk

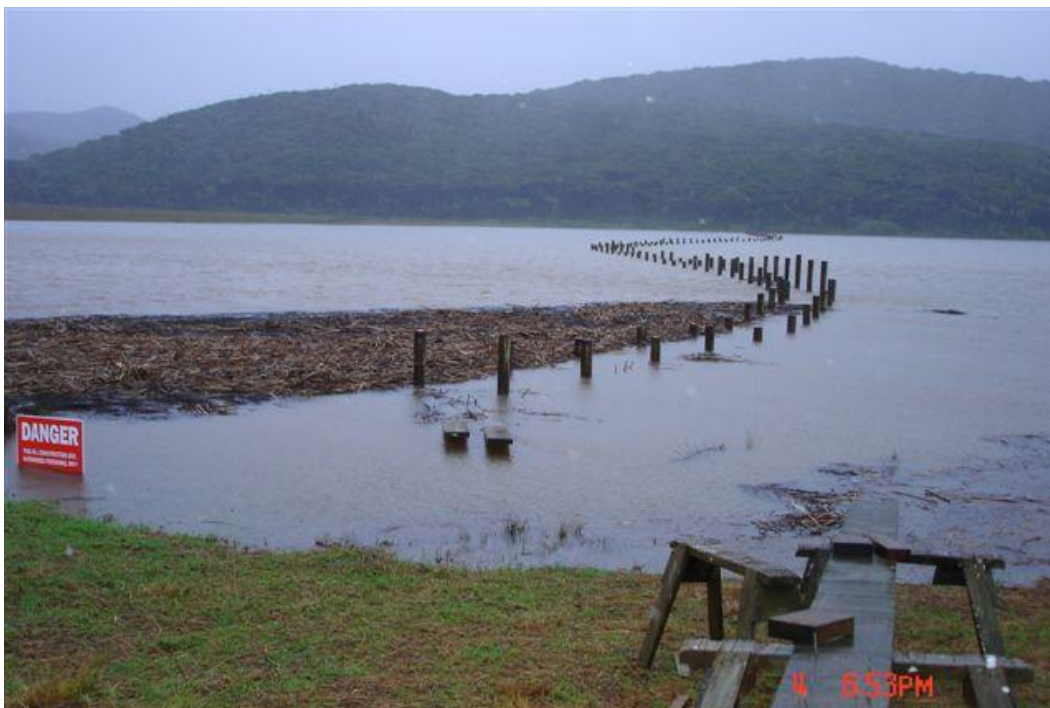
Figure 15: Waitahora Lagoon Boardwalk inundated during construction. Note raised piles and accumulated debris.

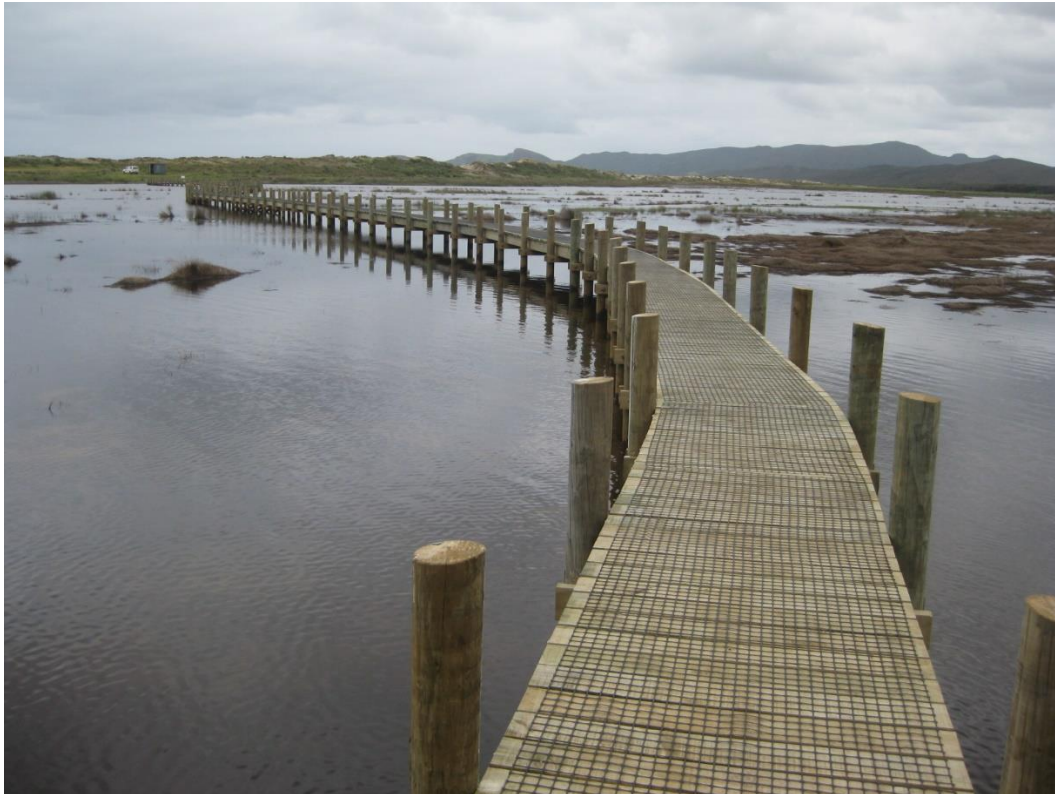
Figure 16: Waitahora lagoon Boardwalk soon after completion in 2012

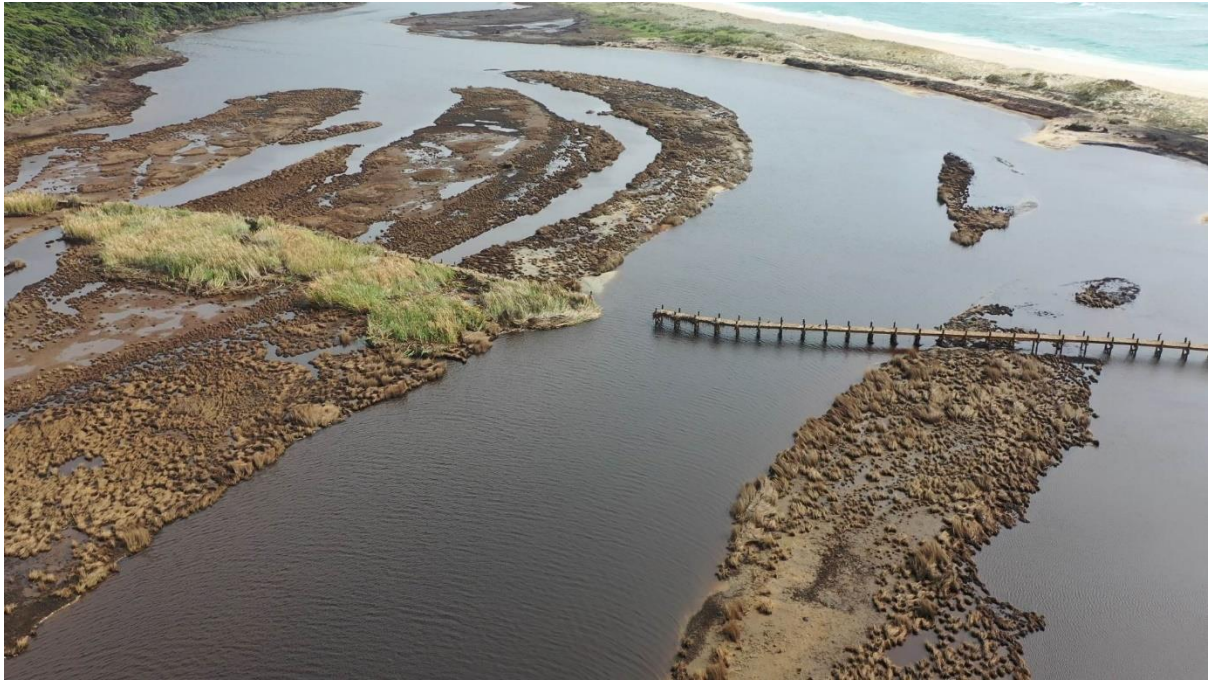
Figure 16: Drone view of Waitahora Lagoon Boardwalk in mid May showing missing 10m section.

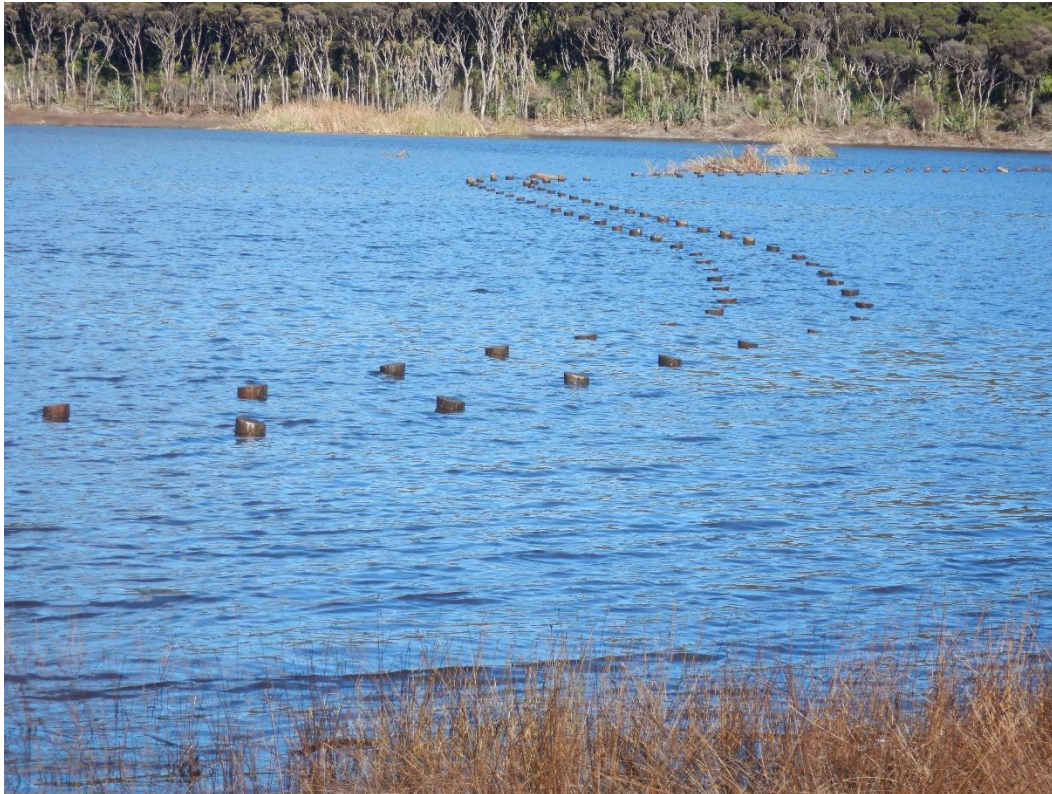
Figure 17: Waitahora lagoon boardwalk at the time of inspection 12.44pm 25 May 2023. Water depth over the boardwalk deck approximately 0.5m.
