Figure 8 Edmonds Ruins, ground plan.

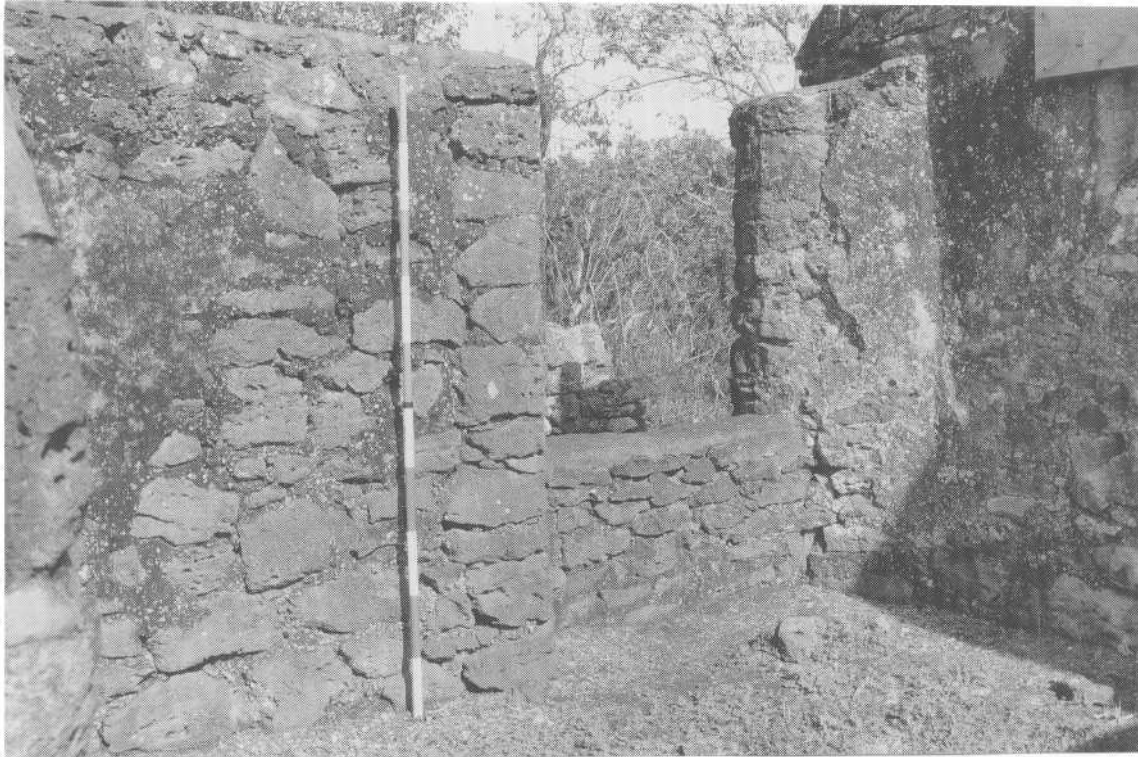
Figure 9 Phase 1 interior: west wall, northern end, 1992.

Window places in both phase 1 and phase 2 structures have sections of narrower walling beneath, with associated angled internal reveals (Figure 9). The consequent alternation of short wall sections of differing thickness, not bonded together, has produced a weak structure. Dressed quoins around the phase 1 west wall windows, together with greater wall thickness, have assisted the survival of these walls despite the lack of bonding, but parts of the weaker phase 2 east wall sections have collapsed.

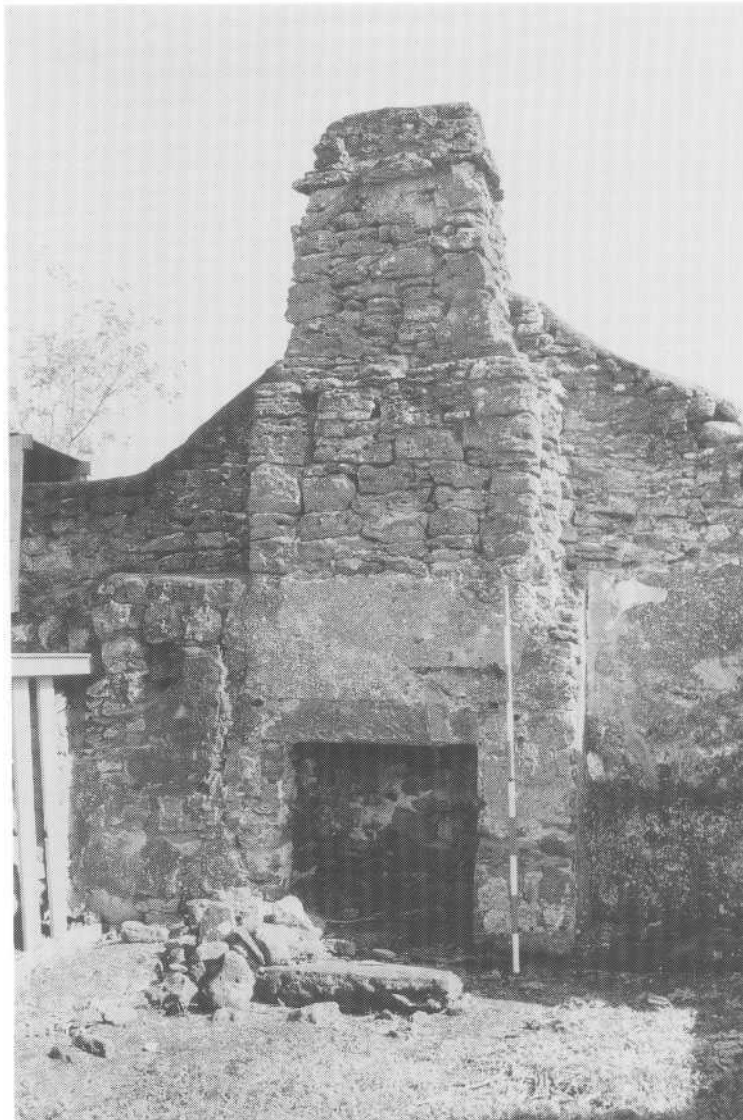
Figure 10 Phase 2 interior: fireplace and chimney, north wall, 1992.

The surviving heights of the walls indicate that there were two gabled rooves, the western, over phase 1 structures, with an eaves height of 2.2 m, and the eastern, over phase 2 structures, with an eaves height of 2.0 m. There would have been two parallel roof apexes trending north to south with a gully between them (see Figure 4). The historic photograph (Figure 7) shows the roof on the eastern phase 2 structure to be shingled on untrimmed purlins without bargeboards, and with a timber box gutter. There is no increase in wall thickness for gable-end walls of greater height. On the contrary, the phase 2 north wall, which includes a chimney in the gable end to a height of 5 m (Figure 10), reduces to a thickness of 500 mm at the western and 400 mm at the eastern side.

- end, still present in the early 1960s (Figure 4), has collapsed.
- (2) On the phase 2 north wall an open fireplace with a flagstone hearth survives (Figure 10). An internal wall cavity on the west side, opening out from a gap inside the chimney, might have been designed to circulate warmth. The chimney is not vertically sided, but has a pronounced batter. Decorative string-coursing is present above the roof level (Figures 7 and 10).

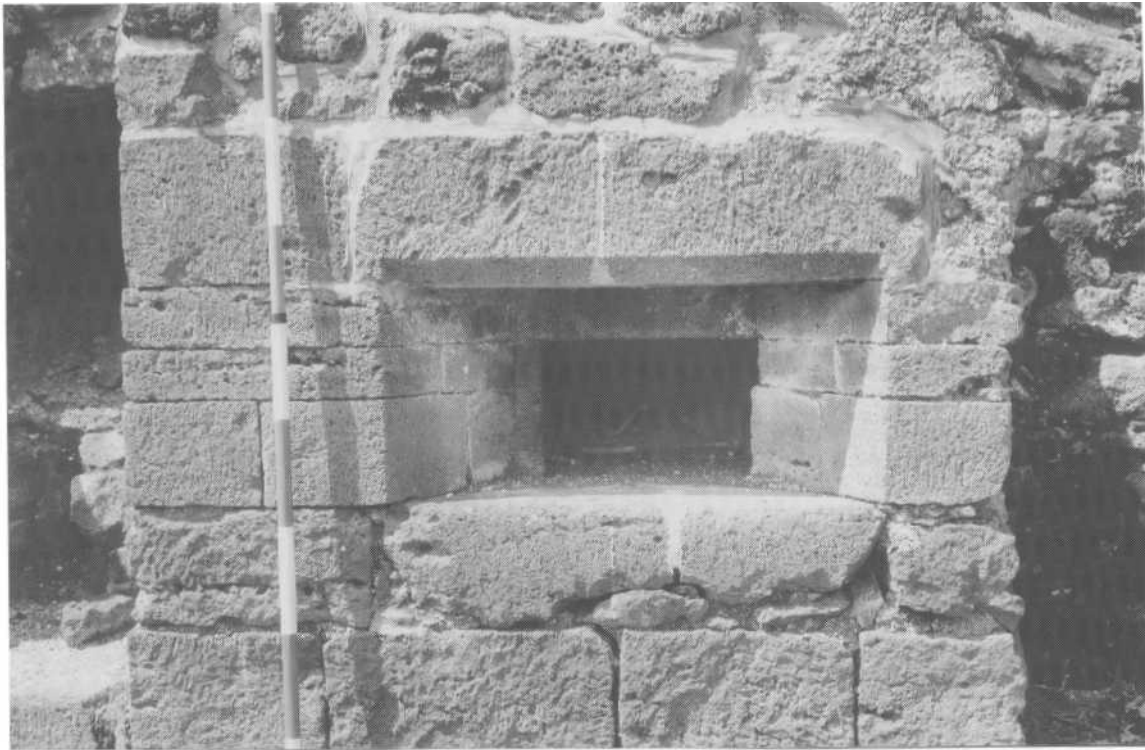
Figure 11 Bread oven structure, south-west room, 1992.

- (1) In the phase 1 south room there is a large bread-oven structure (Figure 11), with a fireplace and flue to the east and addi-

tional masonry infilling on both sides. The oven is of the side flue type (no internal flue) as was used in commercial bakeries (internal dimensions 1200 X 780 mm with an arched roof 500 mm high, all in dressed basalt). The standard of stone dressing is high, suggesting that it was constructed before the death of Mr John Edmonds (1865). The door is missing but the door frame survives (Figure 29). On the outside of the phase 1 south wall, backing on to the oven, a slight bulge appears to be caused by pressure of unbonded masonry on the inside. The presence of an earlier fireplace on the inside of the wall is suggested. This, together with the apparent structural independence of the 750 mm walls from the oven structure, suggests that the oven, with the associated east side fireplace and west side infilling, are later additions in front of an original open fireplace and chimney. The chimney in the phase 1 south gable

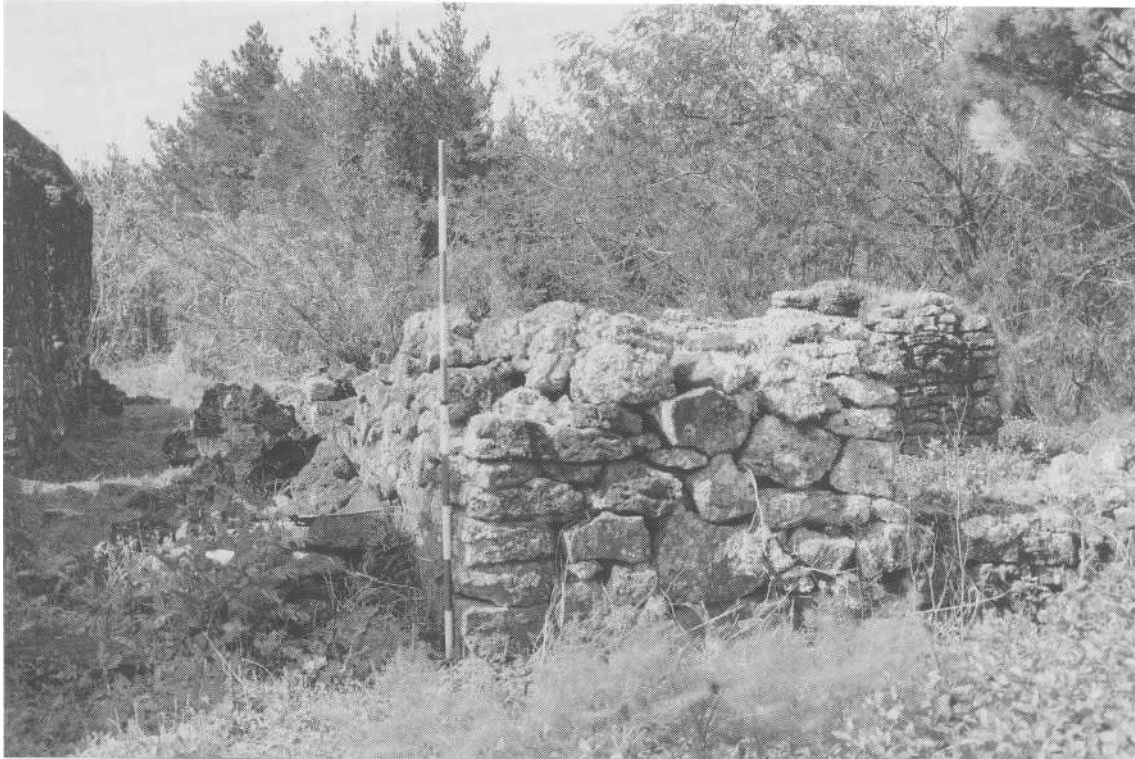
Figure 12 The annexe structure from the north, 1992

Immediately to the west of the main dwelling lie the ruined remains of the annexe (marked as phase 3 on Figure 8; see also Figure 12). This is generally an unmortared loose random rubble structure (Harris 1975: 416) with walls 700-900 mm thick. Some mortar is present around the window positions in the two end walls, evidence of the eastern reveals of which survive in each case (noted on Figure 8), and in what may have been a chimney to the west. This latter structure has walls 500-600 mm thick, unbonded with the rest of the annexe. It may have closed off an earlier doorway. It remains to a height of 1.8 m, greater than the rest of the annexe structure (1.4 m or less).
