PEER REVIEW REPORT FOR WSP DETAILED SEISMIC ASSESSMENT.

Chateau Tongariro Hotel - State Highway 48,
Whakapapa Village, Mount Ruapehu

Document name Peer Review Report of WSP Detailed Seismic Assessment for Chateau Tongariro Hotel - State Highway 48, Whakapapa Village, Mount Ruapehu

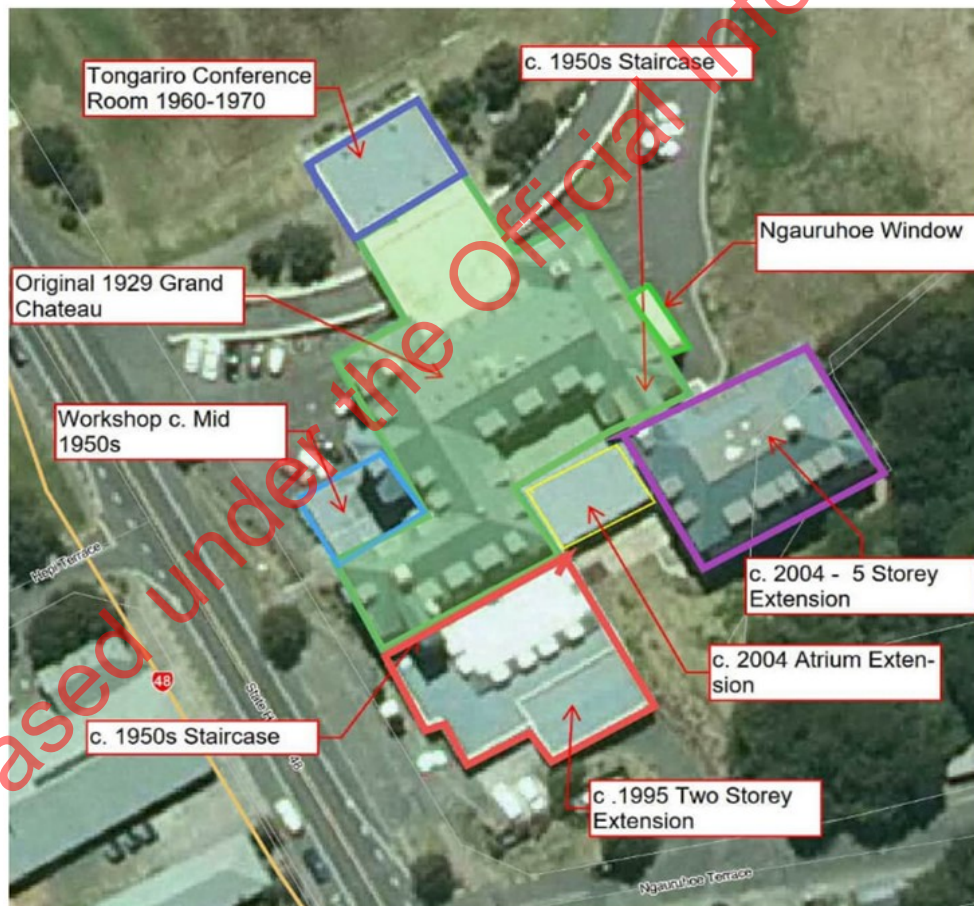
WSP has focused on the original 1929 portion of the complex only. The extent of DSA highlighted in green in Figure 1. Over the years, the original hotel has undergone several alterations and additions of buildings in proximity. These buildings have been constructed either with no seismic gap or with minimal gap between the original hotel. WSP has not taken into consideration the interaction and pounding between these buildings. The potential pounding could cause serious damage to these buildings.

Figure 1 – Current layout of the Chateau Hotel Complex
